PRP Inspections Inc.

SUMMARY REPORT

Client: Jeff Rosa (Market Socal)
Inspection Address: 6952 Temple Terrace Street, San Diego, CA 92119
Inspection Date: 9/14/2022 Start: 9:00 am End: 11:30 am
Inspected by: Michael Durnell

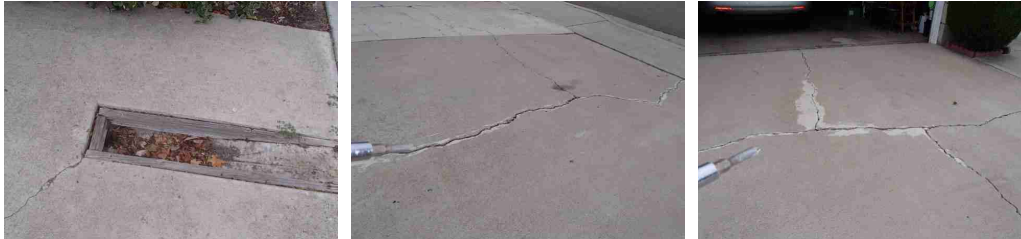
There are offsets in the driveway that could prove to be trip-hazards for children or the elderly and could rub lower cars, which you may to evaluate for yourself.

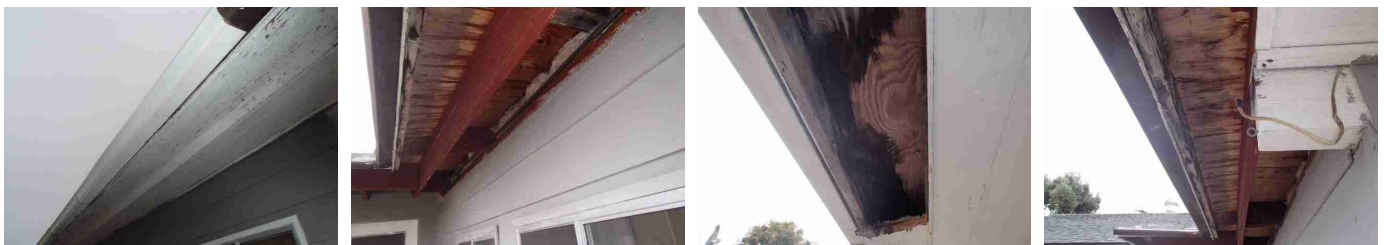
There is water damage to the eaves and sheathing that is visible under the eaves which needs serviced.

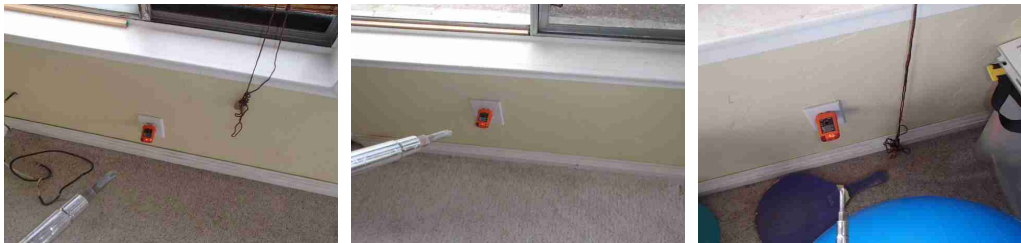
All of the open grounded outlets should have GFCI for electrical safety reasons.

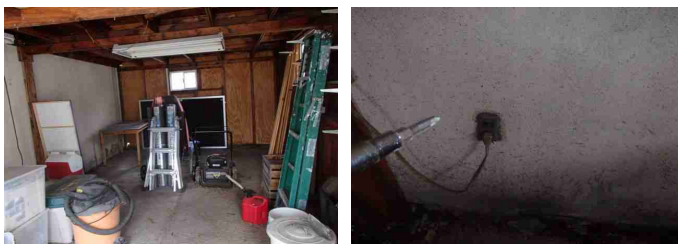
The outlets in the shed should be GFCI for electrical safety reasons. We recommend a licensed electrician evaluated and serviced this condition.

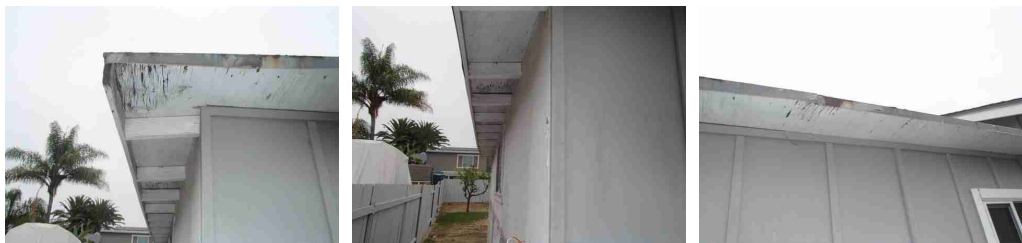
The eaves of the shed are water damaged and should be evaluated by a termite inspector and roofer.

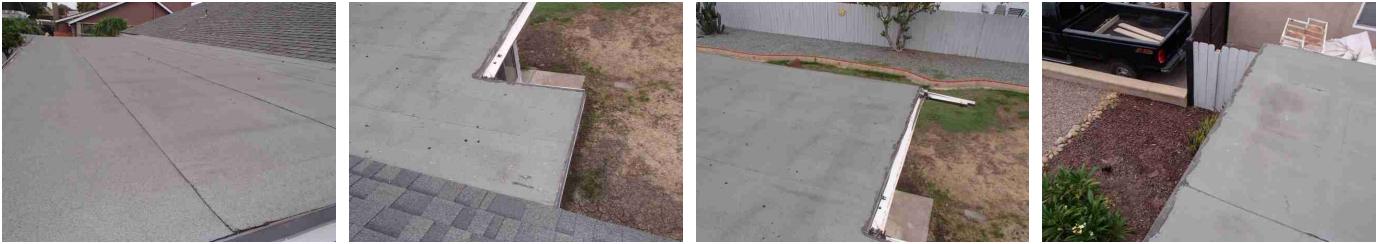
The seams of the flat roof sections and the edges need serviced by a licensed roofer before close of escrow - *Continued*

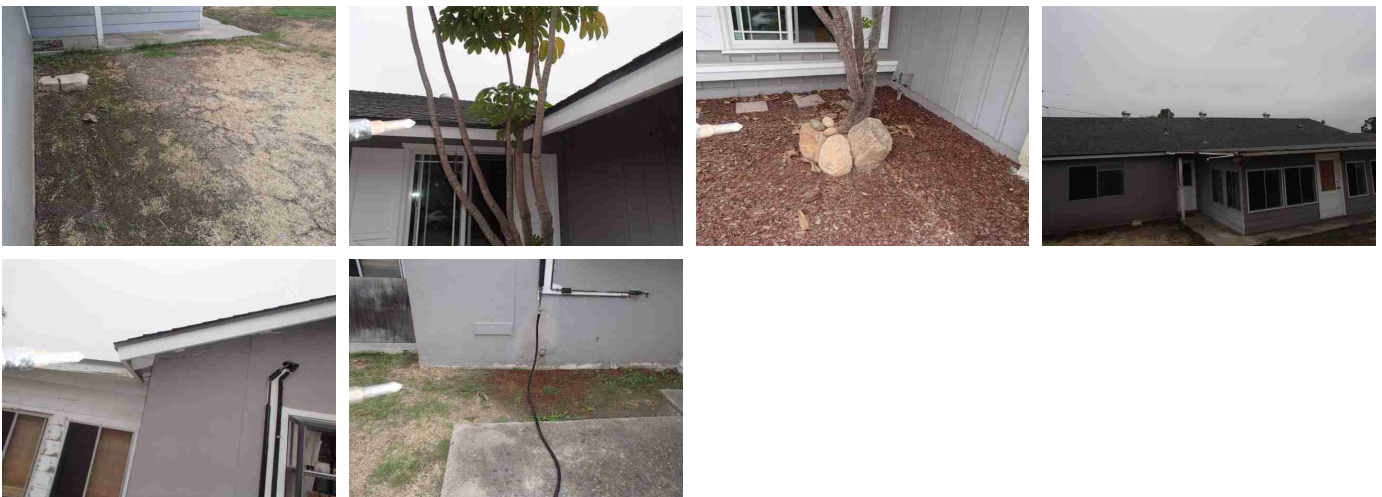
The roof only has partial gutters and full gutters are recommended for the general welfare of the residence and its foundation, inasmuch as moisture is a perennial problem on any property which can lead to settling and cracking of the foundation stem walls.

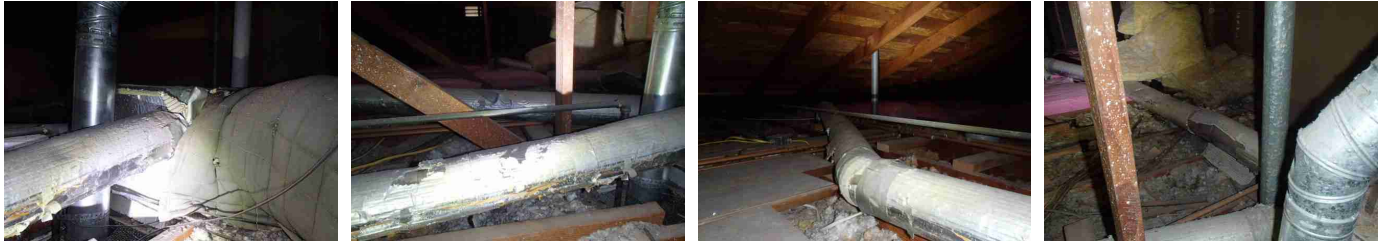
The ducts are an old and obsolete type that are insulated with a known asbestos-containing material. However, portions of the sleeve insulation are open and have fallen away from the ducts, which should be evaluated by an asbestos abatement contractor.

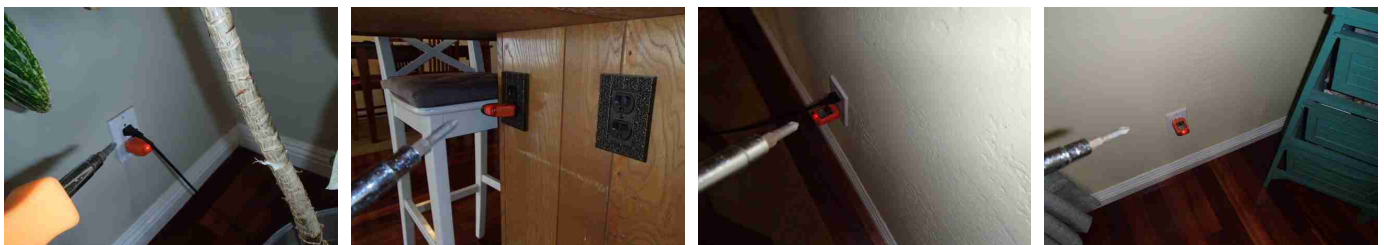
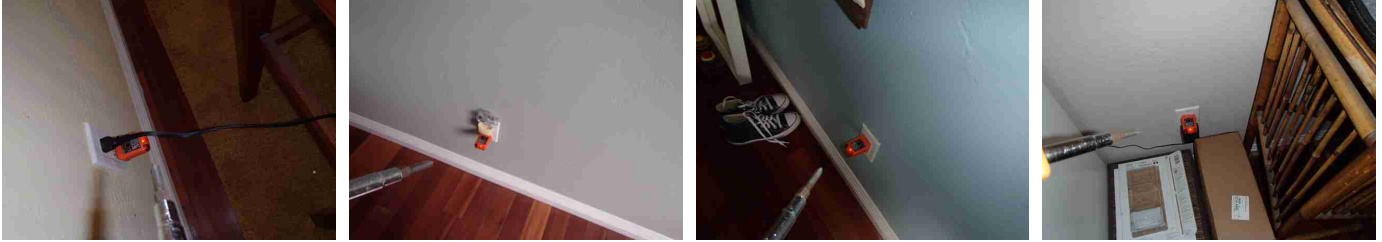
Most all of the outlets in the home are ungrounded and have three pronged outlets installed. This allows you to plug in electrical components that by today's regulations are required to have grounds. This condition should be evaluated and a ground fault circuit interrupter breaker should be installed on each circuit and or in the main electrical panel.

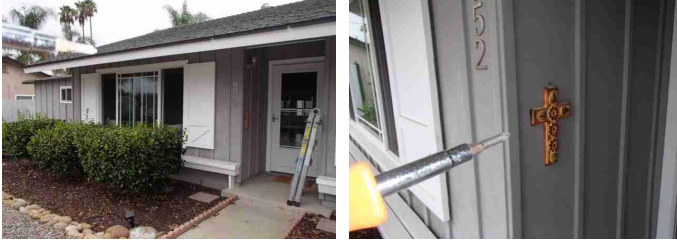
There is no doorbell, and you may wish to have one installed. They make battery operated ones that are a simple install.

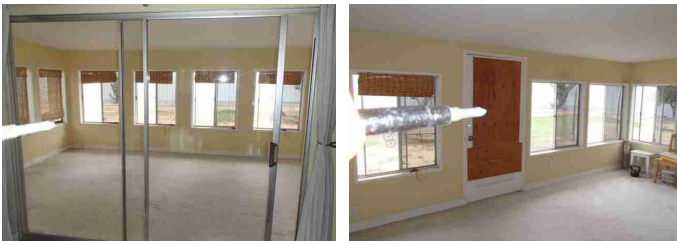
The sliding glass doors do not appear to include tempered glass. For safety reasons, many local jurisdictions require the moving portion to be safety-filmed. However, if children occupy or visit the premises, you may wish to safety-film the stationary portion as well.

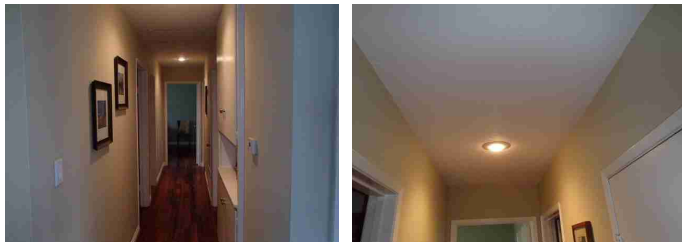
There is no smoke detector and one is mandated which should be installed for obvious safety reasons.

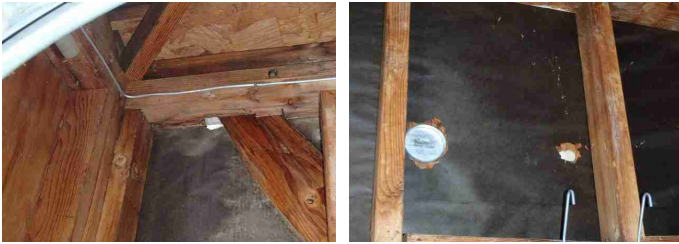
There are open voids in the walls that should be sealed to keep out pests or birds.

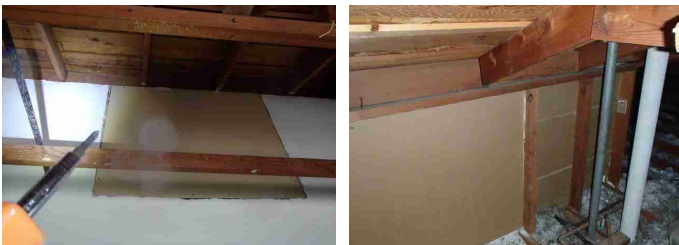
The void in the garage firewall must be repaired, in order to maintain the necessary firewall separation between the garage and the residence.

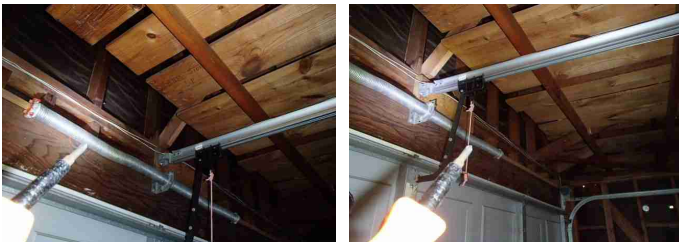
The cables are loose and the springs need serviced by a licensed garage door specialist. The springs that lift the door should be tightened to the proper tension by a specialist. The door should be able to be open manually with minimal effort and hold the door in the full open position if the unit fails or the power is out.

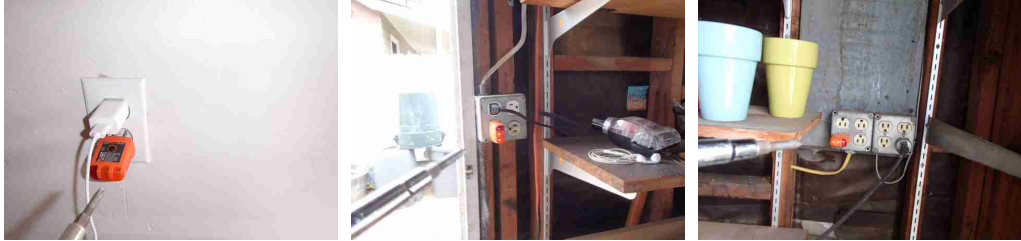
All the outlets should have ground fault protection, which is mandated by current standards and is an important safety feature.

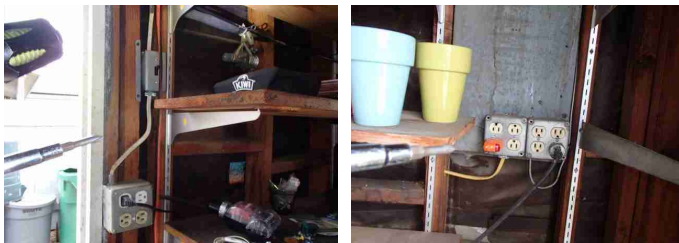
There is exposed electrical romex below 8.5 ft that we recommend be in conduit or covered to protect the wire.
